■ **BIOMATERIALS**

A retrieval analysis of the Precice intramedullary limb lengthening system

Bone Joint Res 2018;7:476–484.

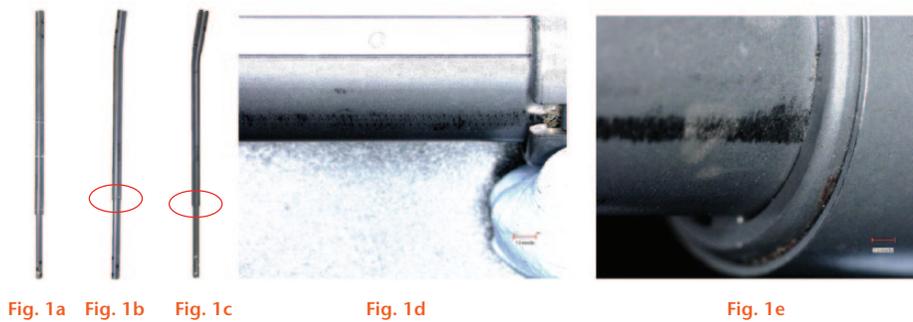
a) First-generation nail, shown by the presence of three welds and supported by the lot numbers referred to as P1. b) Second-generation nail, shown by the absence of welds and supported by the lot numbers referred to as P2. c) Second-generation nail, second modification, shown by the absence of welds and crown and supported by the lot numbers, referred as P2.1. d) Part of the crown on the actuator of a retrieved P2 (a magnification of the circled area of Figure 1b). e) Absence of the crown on a retrieved P2.1 nail (a magnification of the circled area of Figure 1c).

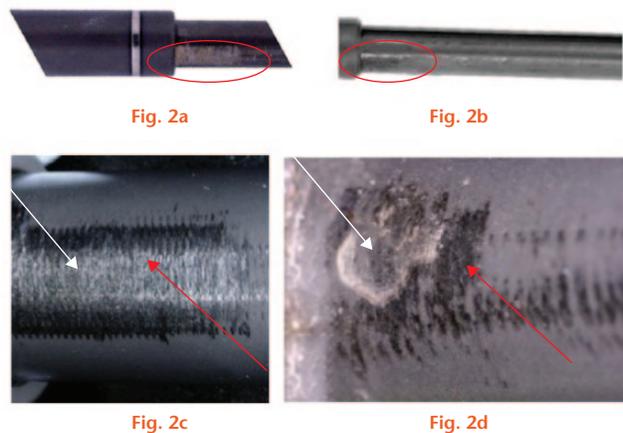
Patterns of damaged surface on the telescopic part of the nail. a) Retrieved P1 nail with wide marks on the telescopic part. b) Marks on retrieved P2.1, narrower compared with the marks of P1. c) Fretting (red arrow) and pitting (white arrow) corrosion present on the surface degradation on the telescopic part of P1 nail under the optical microscope (50× magnification). d) Fretting (red arrow) and pitting (white arrow) corrosion present on the telescopic part of P2.1 nail shown by the microscopic inspection (50× magnification).

Macroscopical inspection. This revealed two different patterns of surface degradation on the telescopic part of the implants. All P1 implants sustained deeper marks, starting as narrow horizontal lines with wider horizontal lines close to the actuator part of the nail (Fig. 2a). Some of the implants had black debris on the markings. Biological tissue was located in the gap between the outer shell and the telescopic part of some of the implants.

In the P2 and P2.1 designs, the marks were less visible, and all appeared to be of equal width (Fig. 2b). The marks were noted to be deeper on the telescopic rod closer to the wider outer casing.

Microscopical inspection. On microscopical inspection of the surface, damage to the telescopic part, fretting, and pitting was noted on all designs, as shown by the red and white arrows, respectively, in Figures 2c and 2d.

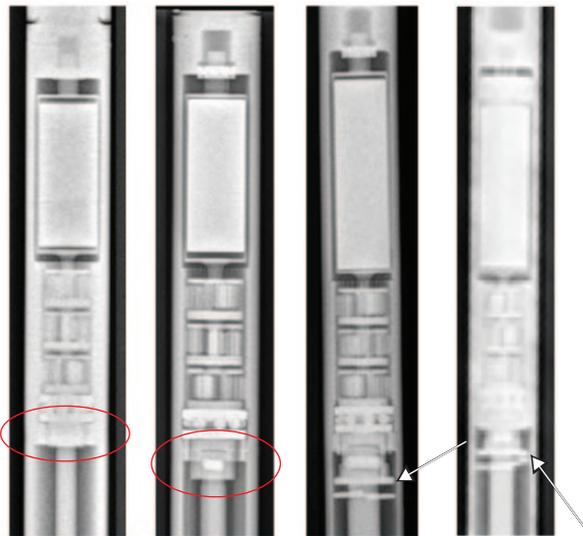
Plain radiographs. The lengthening recorded forensically and radiographically is presented in Table III. The state of the internal mechanism was further analyzed and the plain radiographs showed no signs of fracture of the internal mechanism. Representative radiographs from four implants are shown in Figure 3. Although all P1 nails had the same external appearance, radiographical analysis confirmed differences in the internal mechanisms. The implant identification numbers (lot numbers) that represented the earliest nails inserted were designed with a longer frame around the actuator pin, highlighted with a red circle in Figure 3a. Later implanted P1 nails with higher lot numbers were noted to have a smaller frame around the pin, the red circle seen in Figure 3b. The P2 and P2.1 internal design had two metallic rings surrounding the thread mechanism of the nail, highlighted by arrows in Figures 3c and 3d.

Plain radiographs of different internal mechanisms in retrieved Precice nails. a) Radiograph of early P1 design, with a longer frame compared with the rest of the designs. b) Radiograph of the later P1 design with a smaller frame. c) Radiograph of P2 design with an arrow showing the metal rings close to the actuator pin. d) Radiograph of P2.1 design with an arrow showing the metal rings.

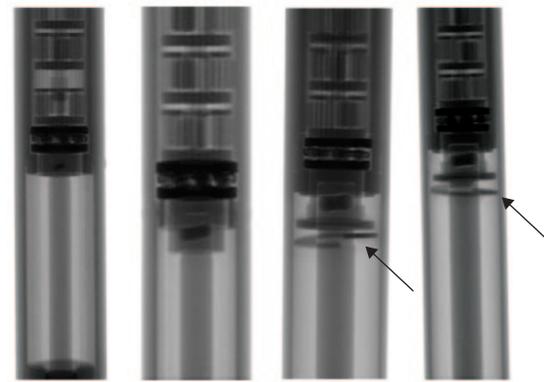
X-ray micro-CT. We selected four implants: two P1 nails (including one early and one late design), one P2 nail, and one P2.1 nail for further analysis. The scans confirmed the same differences between the designs, as the plain radiographs demonstrate in Figure 4; the black arrows highlight the metallic rings. The difference in size of the actuator pins can also be clearly seen.

Micro-CT of different internal mechanisms/designs. a) Micro-CT of early P1 design with the arrow showing the increased frame. Comparing the pin with the micro-CT scans of the other designs shows a smaller pin, which sectioning revealed a fragment of the pin missing. b) Micro-CT of later P1 design with a larger actuator pin. c) Micro-CT of P2 and d) micro-CT of P2.1 designs revealed a similar internal mechanism. Presence of metal rings is shown with arrows.

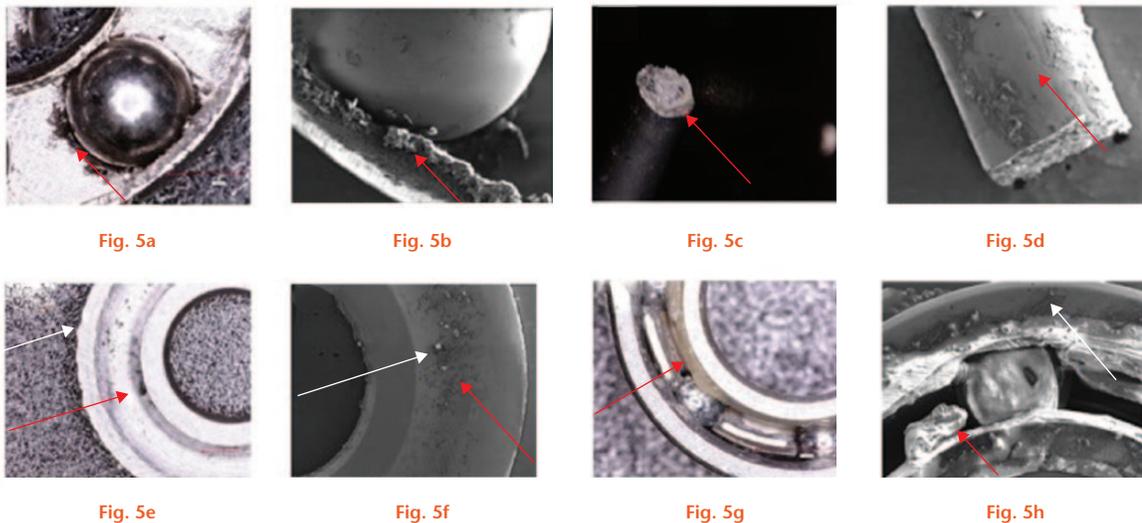
In the early P1 design, pin and bearings, phosphorus, sulphur, and high amounts of oxygen were found indicative of corrosive debris. Titanium transfer from the nail to the internal parts was also detected. In the later P1 nail, sulphur and a high amount of oxygen on the pin were also noted as corrosive deposits.

Microscopic inspection of internal parts of early P1 design. a) Microscopic picture of the ball bearing where black debris was found (arrow). b) Scanning electron microscopy (SEM) with presence of foreign materials on the ball bearing (arrow). c) Fractured site of the pin (arrow) showing a brittle fracture with no evident initiation or end points of the crack. d) SEM showed the rough surface of the fracture, combined with black debris on the side of the actuator pin (arrow). e) Black deposits on the plain bearings (red arrow) and fretting more prominent on the exterior part of the bearing (white arrow). f) SEM revealed black debris (red arrow) and biological material (fluorescent debris, indicated by the white arrow). g) The ball bearing previously situated at the bottom of the gearbox had a fat-like substance (arrow), most likely lubricant to facilitate motion within the internal mechanism. h) SEM confirmed the presence of fat-like substance (red arrow) and black debris (white arrow).

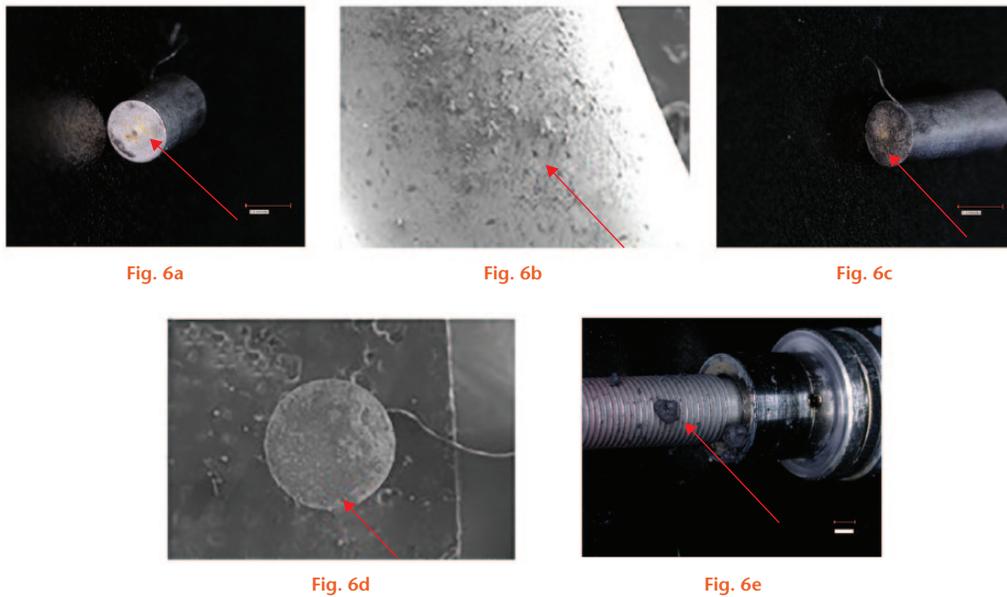
Microscopic inspection of internal parts of a later P1 design. a) Non-fractured part of the actuator pin with presence of debris (arrow). b) Scanning electron microscopy (SEM) showed black debris on the side of the pin. c) Fractured site of the pin, with black debris, but with no clear indentation of the initiation and endpoints of the fracture. d) The initiation point was not evident using the SEM, suggesting a more brittle fracture. e) Black stained materials on the thread mechanism of the nail.

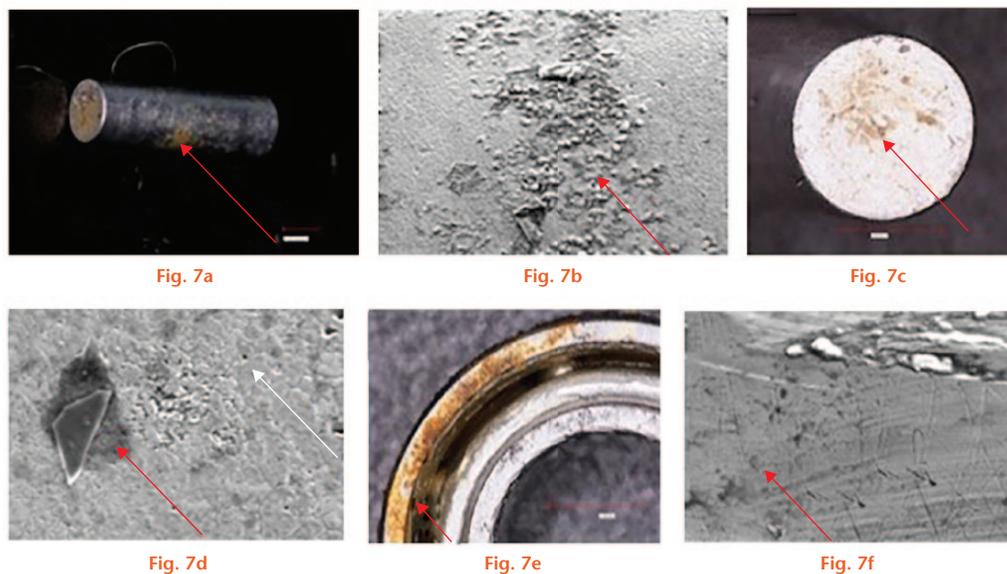
Microscopic inspection of internal parts of P2. a) Foreign material on the pin (arrow) while b) scanning electron microscopy (SEM) showed no presence of black debris, only biological deposits on the side. c) Minor presence of black debris on the top of the pin (arrow), while d) SEM showed some black debris (red arrow) and pitting corrosion (white arrow). e) Ball bearing with debris and deposits (arrow), which f) under SEM inspection revealed presence of black debris (arrow).

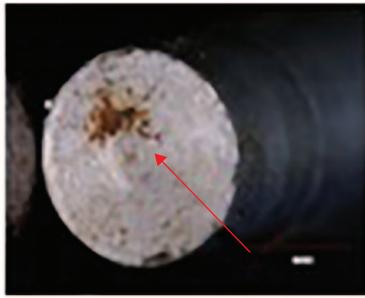
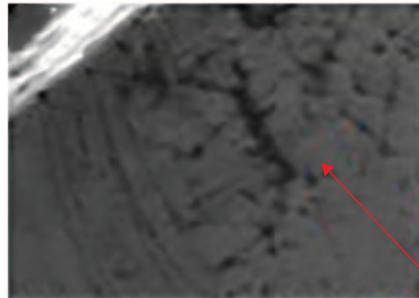
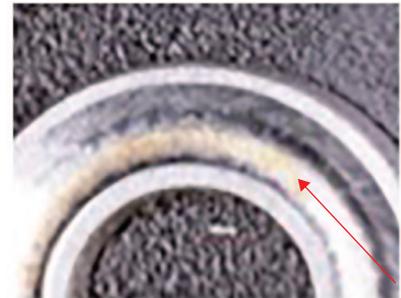
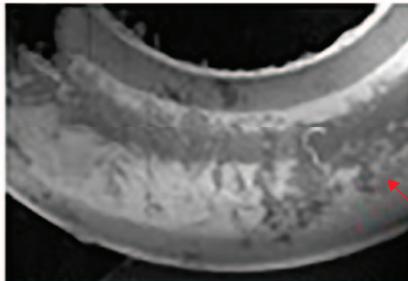
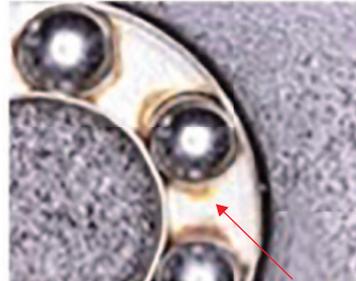
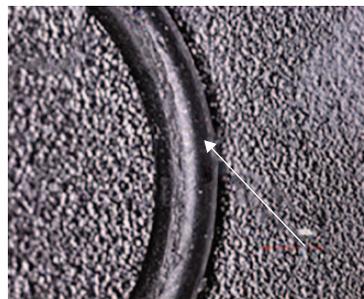
All internal parts were found intact apart from the actuator pins of both P1 designs (Figs 5c and 6c). Black debris was found in all the sectioned implants on the threading of the telescopic part, as seen in Figure 6e. In the P2.1 example, a black rubber ring (Fig. 8g) was retrieved, which was not present in the other nail designs. It is presumed that this was inserted to prevent fluid ingress from the movement of the telescopic part during lengthening. There was scratching on the surface of the ring, denoted by the white arrow in Figure 8g.

Microscopic inspection of internal parts of P2.1. a) Presence of foreign substances on the pin (arrow), while b) under the scanning electron microscopy (SEM) we observed black debris. c) The plain bearing had a small amount of foreign debris, which d) was more extended when we performed SEM (arrow). e) On the ball bearings, there was foreign materials (arrow), but not that extended, as f) SEM revealed. g) On the rubber ring, there was scratching on both sides (arrow).
